Viability of European bird cherry (*Prunus padus* L.) seed after two-year retention in traps along the Chester and Campbell Creek Trails, Anchorage, Alaska

Alaska Natural Heritage Program, University of Alaska Anchorage
L. Flagstad, H. Cortés-Burns, E. Johnson, L. Simpson, A. Brownlee
707 A Street
Anchorage, Alaska 99501

Municipality of Anchorage
Parks and Recreation
City Hall
632 West 6th Avenue
Anchorage, Alaska 99501

November 18, 2010

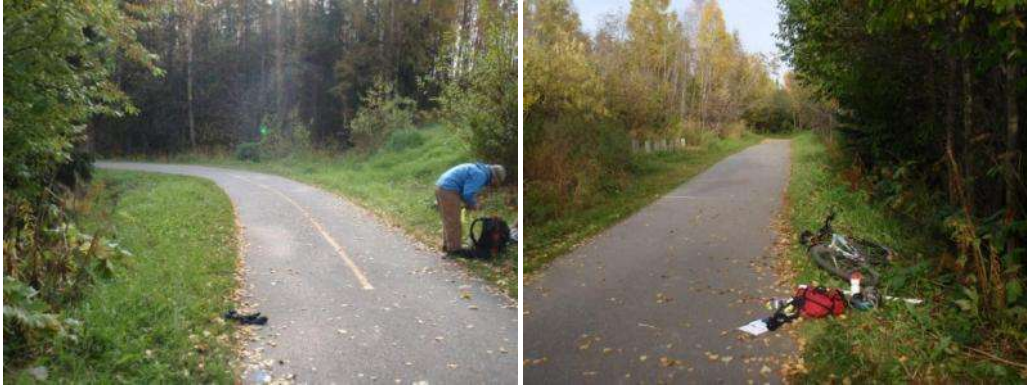
Figure 1. View from south (left photo) and north (right photo) of plot BCT 17 (N 61.17152°, W -149.87222°).

¹ The seed trap at plot BCT 17 contained at least two (and maybe four) one-year-old seeds. The surfaces of the suspect seeds were shiny, chestnut-colored and showed minimal wear, whereas surfaces of two-year-old seeds were typically dull or matte and grayish-brown-colored. All four of the suspect seeds tested viable. Two (the shiniest) of these seeds are not included in the totals, thus reducing the percent viability from 33 to 27%.

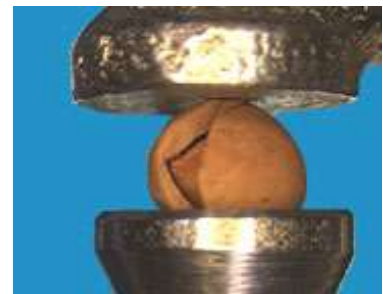
Figure 2. Endocarp cracking along seam using a small vice (AOSA 2007).

Seeds were prepared for staining by soaking them in lidded plastic vials of deionized (DI) water for 12 hours at room temperature (20-25°C). After 12 hours, the endocarp was cracked and removed using a pair of needle-nose pliers. Three of the 37 seeds selected for testing cracked quickly, causing the embryo to split in half or become slightly crushed. For this reason, a small vice would be a more effective tool for cracking the endocarp, as it would allow greater control of the pressure applied (Figure 2). Eight of the 37 seeds selected for testing were already split in half when the endocarp was removed. Split embryos could still be stained, despite the occasional separation of the cotyledon and radicle. Seeds that were completely rotten (black, moldy, gooey) when the endocarp was removed were not tested for viability with tetrazolium, but were simply counted as 'unviable'. Seeds with minimal necrosis were tested.

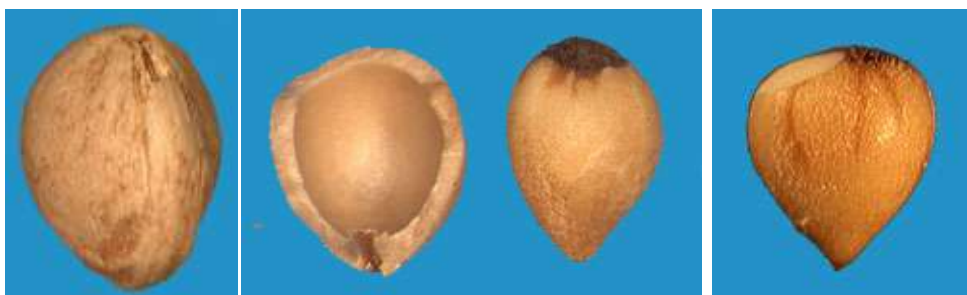
Figure 3. External view of endocarp, left. Endocarp and seed, middle. Seed coat showing nick at distal end, right (AOSA 2007).

After the endocarp was removed, the seed coat was nicked using a small razor blade at the distal end (Figure 3, 4). It is important to take care with this step as it is necessary to fully nick the seed coat, without cutting into the embryo. Nicked seeds were transferred back to their vials and soaked in fresh DI water for 48 hours at 20-25°C; water was changed every 24 hours. We recommend that in future testing efforts, the seeds soak for a full three days to facilitate removal of the seed coat and nucellus from the embryo (Figure 5). The seed coat and nucellus were removed using two pairs of tweezers. Again, care must be taken in this step to avoid damaging the embryo.

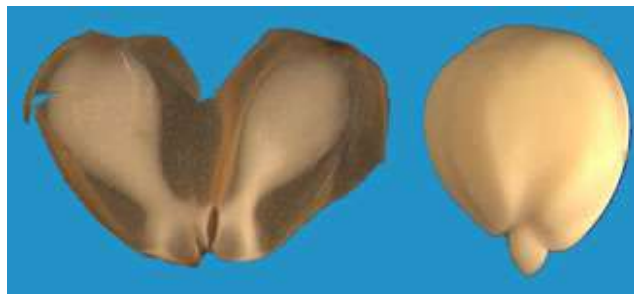
Figure 5. Seed coat and nucellus, left. Embryo, right (AOSA 2007).

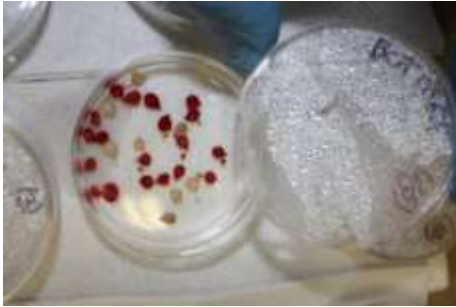
Figure 7. Example of tetrazolium seed viability test results. This test differentiates live, respiring seeds (red) from dead, non-respiring seeds (white) based on color.

This biochemical test differentiates live from dead tissue based on color. Respiring tissue of the embryo stains red, whereas non-respiring tissue of the embryo does not stain (remains white, Figures 6, 7).
