Moose Creek Fish Habitat Restoration Project

Chickaloon Village Traditional Council

Presentation Outline

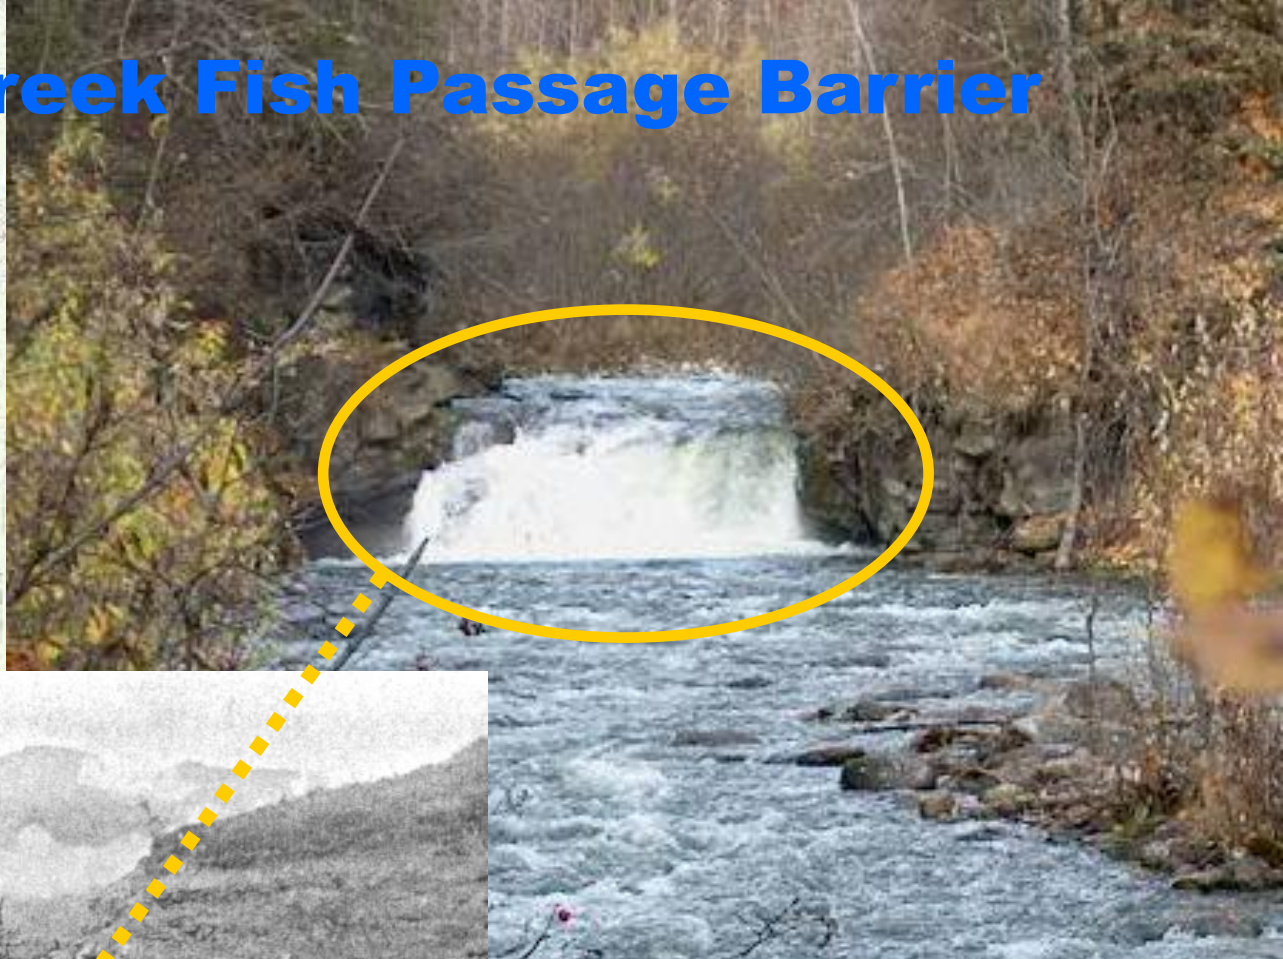
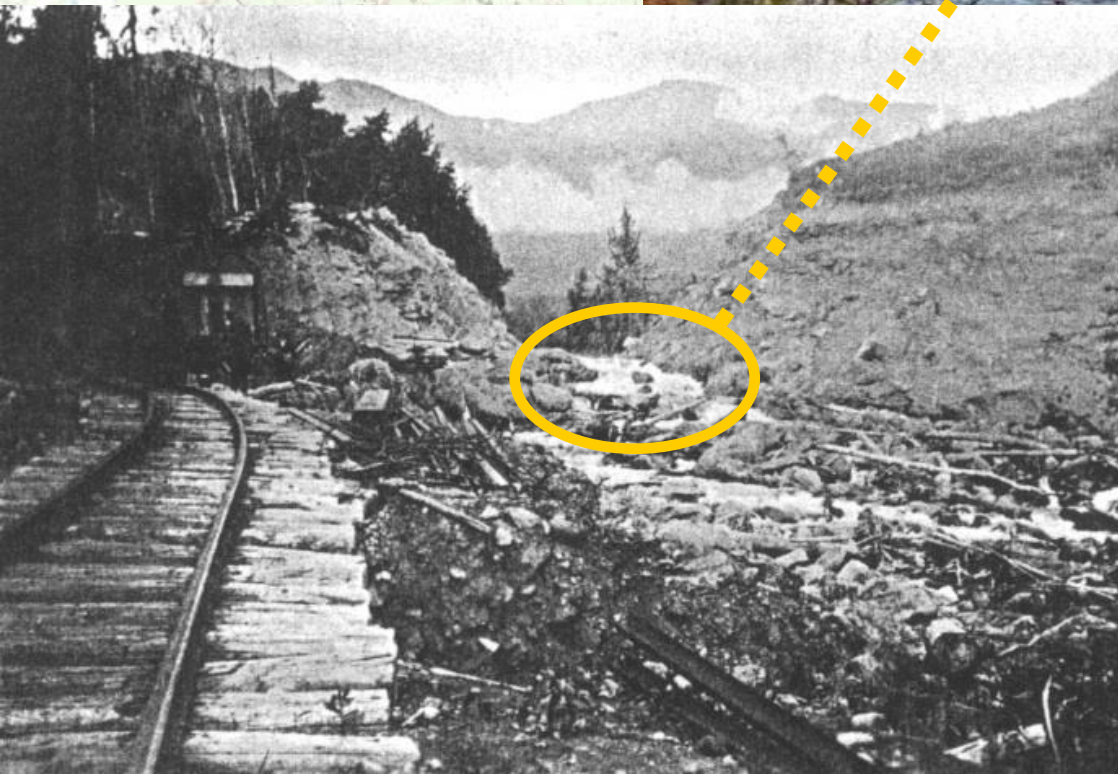
Moose Creek Fish Passage Barrier

Beginning in the 1920's, coal mines and a railroad were constructed in the lower 7 miles of Moose Creek.

Creek meanders were cut off, and barrier waterfalls formed. Salmon were blocked from the upper watershed.

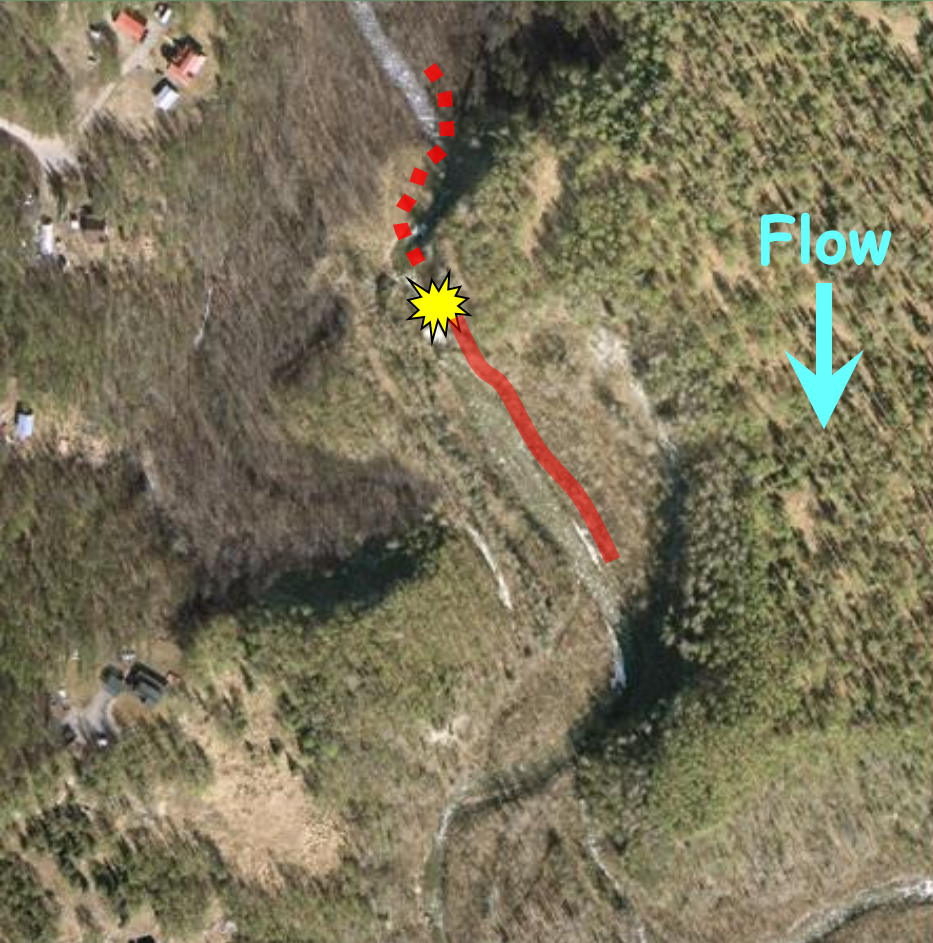
Phase 1 Pre-project:

- 1,065 feet long

NO salmon upstream of 10-ft waterfall for decades

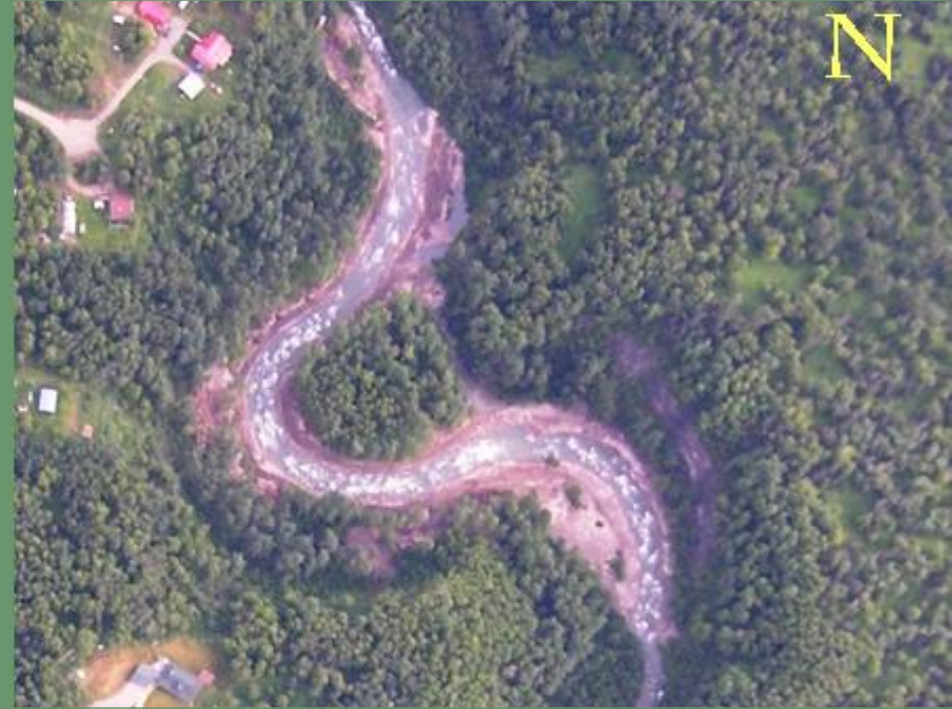
Phase 1 Post-project:

- 1,850 feet of new channel

- Salmon access to > 7 miles + tributaries and wetlands
- Over 200 king salmon observed spawning upstream of project within days of completion

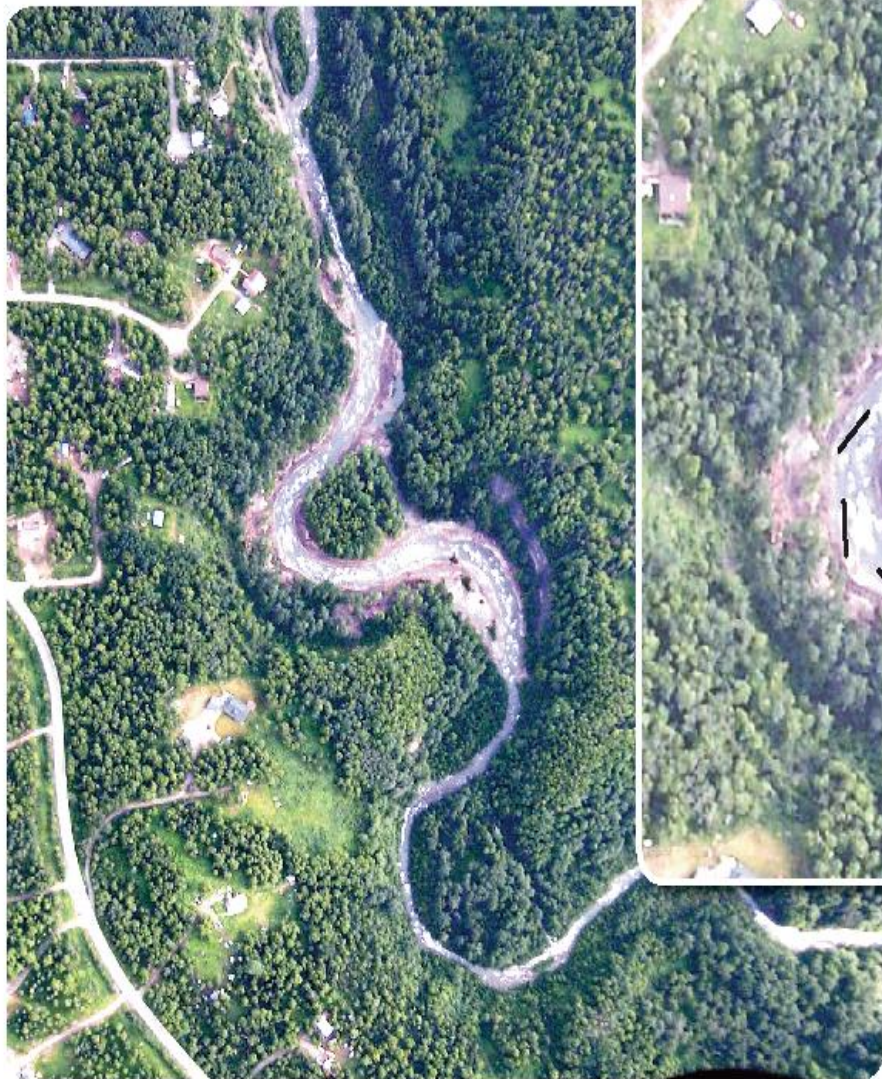
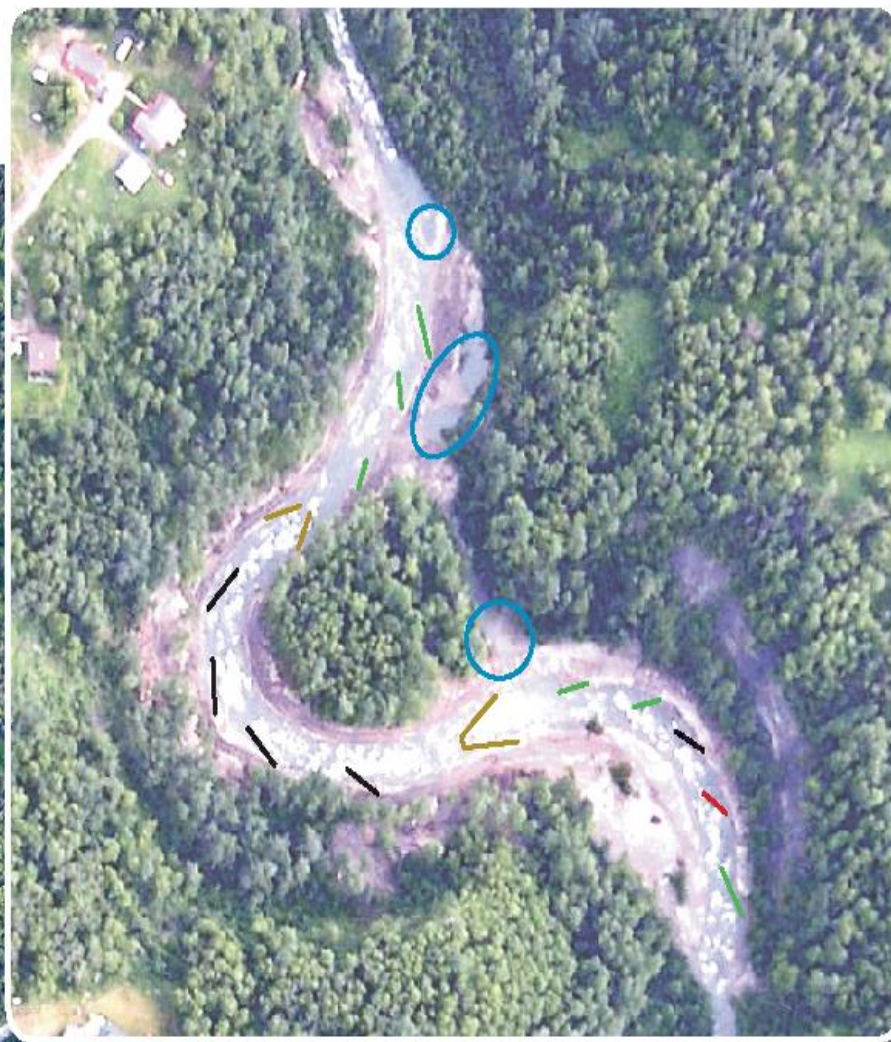
Engineered Structure & Off-Channel Habitat Placement

- Cross-Vane Weir
- Rock-Vane
- Cobble-Vane
- Rock-Log Vane
- Off Channel Habitat

* Approximate Location of Structures

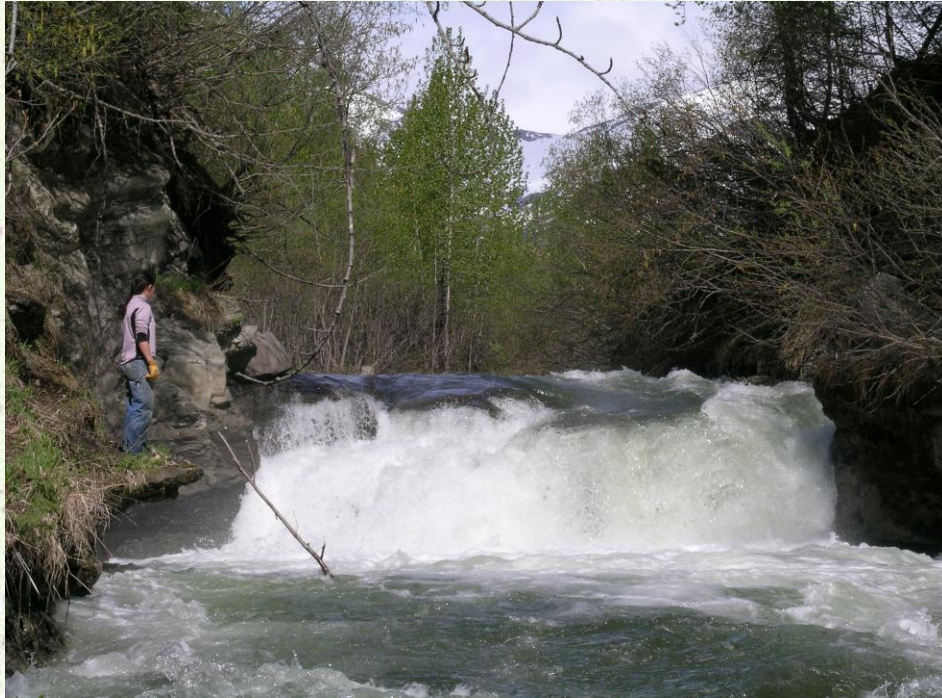
Large Waterfall = Salmon Barrier

Waterfall *Before* Restoration

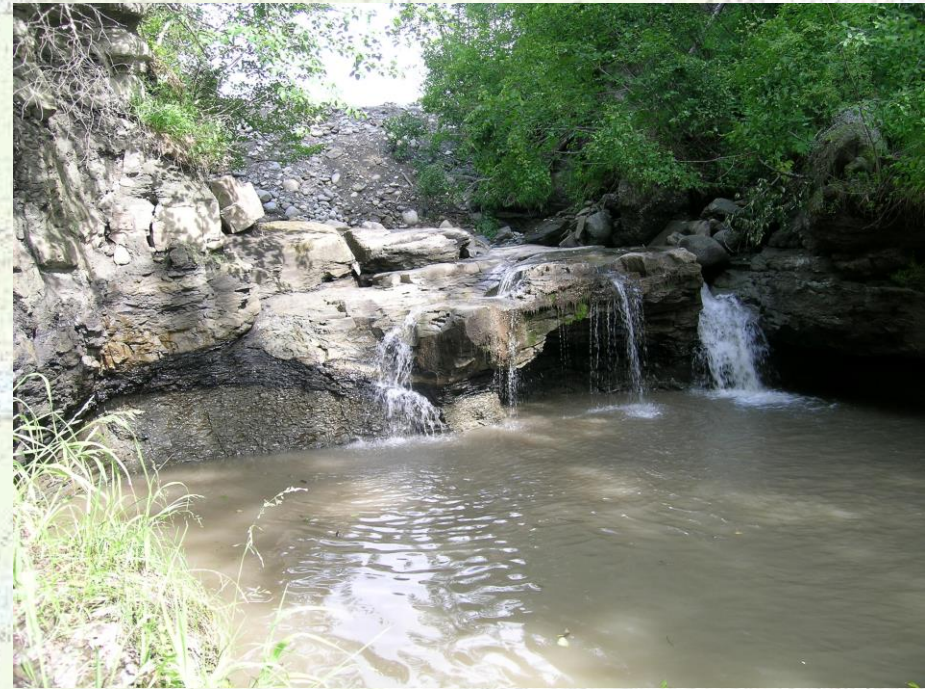
Waterfall *After* Restoration

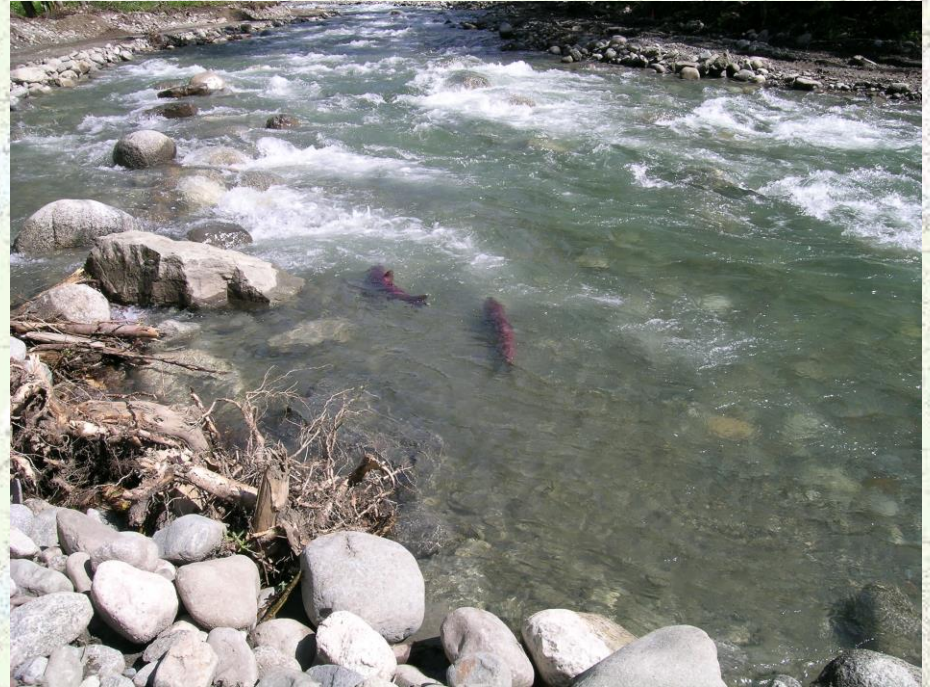
Chinook Salmon Survey 2005

- **215** Adult Chinook salmon counted upstream of the restoration project site

- Chinook salmon counted more than **5 miles** upstream of the restoration project site!!

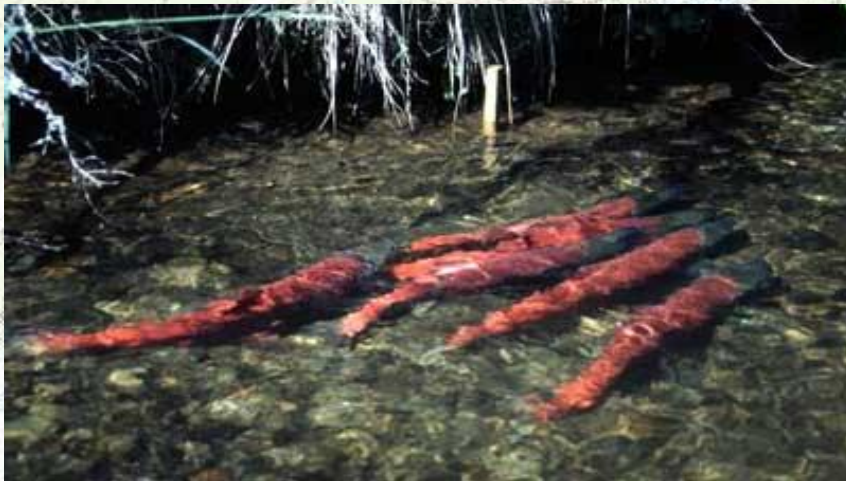
Chinook Salmon Survey 2006

- 556 adult Chinook salmon were counted in Moose Creek at the end of July (foot survey).
